DEPARTMENT OF TRANSPORTATION**DIVISION OF ENGINEERING SERVICES**

Contract #: 04-0120F4Cty: SF/ALA Rte: 80 PM: 13.2/13.9File #: 69.28**WELDING INSPECTION REPORT****Resident Engineer:** Pursell, Gary**Address:** 333 Burma Road**City:** Oakland, CA 94607**Report No:** WIR-001059**Date Inspected:** 29-Nov-2007**Project Name:** SAS Superstructure**OSM Arrival Time:** 1400**Prime Contractor:** American Bridge/Fluor Enterprises, a JV**OSM Departure Time:** 2300**Contractor:** Zhenhua Port Machinery Company, Ltd (ZPMC), Changxing Island **Location:** Shanghai, China**CWI Name:** Gui Yi Ru, Xu Xianping**CWI Present:** Yes No**Inspected CWI report:** Yes No N/A**Rod Oven in Use:** Yes No N/A**Electrode to specification:** Yes No N/A**Weld Procedures Followed:** Yes No N/A**Qualified Welders:** Yes No N/A**Verified Joint Fit-up:** Yes No N/A**Approved Drawings:** Yes No N/A**Approved WPS:** Yes No N/A**Delayed / Cancelled:** Yes No N/A**Bridge No:** 34-0006**Component:** OBG**Summary of Items Observed:**

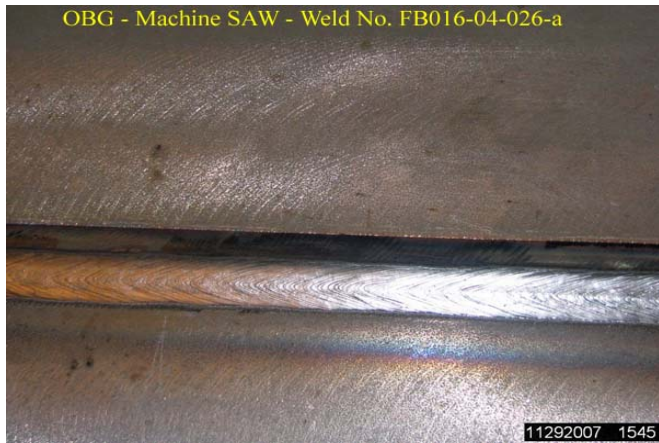
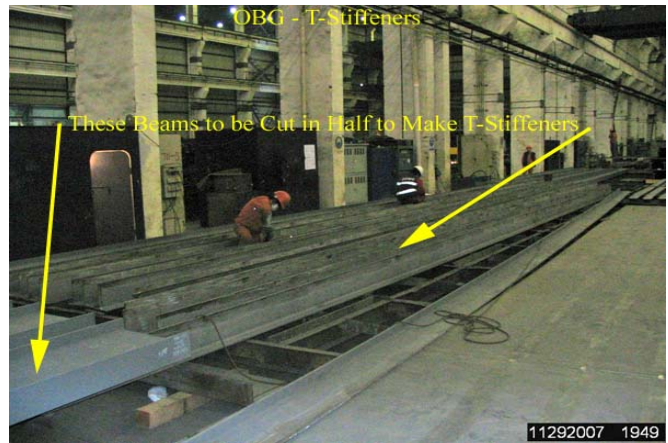
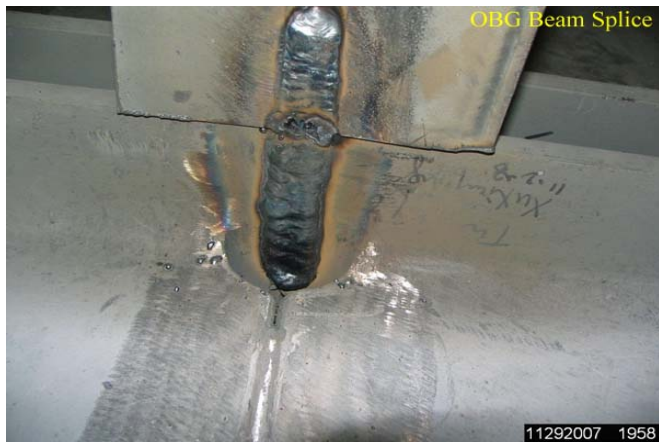
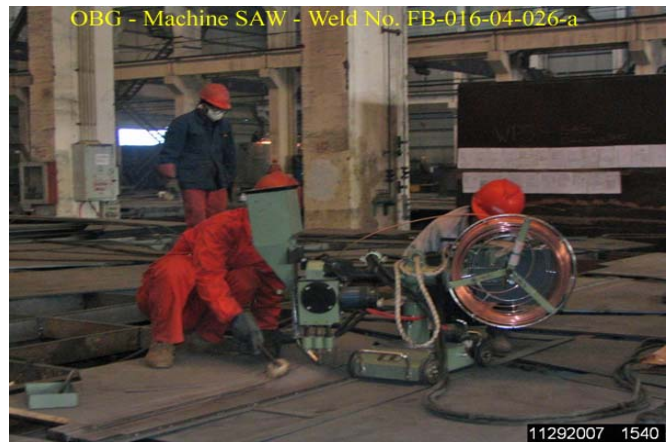
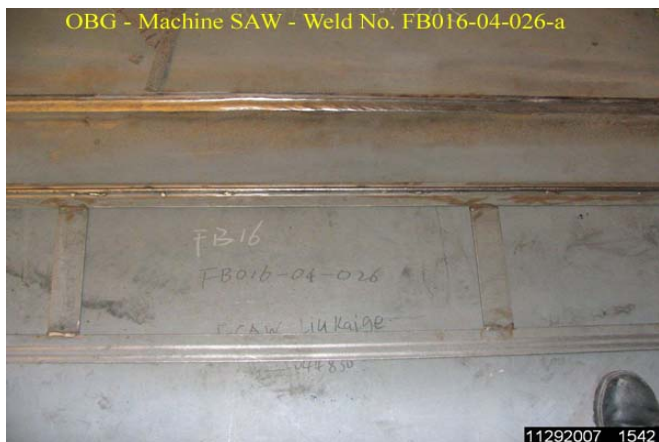
The Caltrans QA Inspector randomly observed machine Submerged Arc Welding (SAW) of floor beam splice, Weld No. FB016-04-026-a on the OBG. The "a" in this designation represents Side A. This joint will be backgouged and welded on the opposite side. This weld joins 30 mm thick ASTM A709M-345-F2-X-Z to 12 mm thick A709-345-T2-X. The 30 mm material was tapered down to match the 12 mm thick material. The Welding Procedure Specification (WPS) being used was WPS-B-T-2221-B-L2c-S-1. The welding operator was Wang Min (I. D. No. 048296). The QA Inspector observed that ZPMC CWI, Gui Yi Ru (AWS CWI No. 00072221) was present during the welding. It was also observed that ZPMC's documentation of welding parameters for minimum/maximum preheat/interpass temperature, voltage, amperage and travel speed, showed them to be within the ranges specified on the WPS up until the time of random observation. It was observed that the filler material, AWS EM12K; and the flux, AWS F7A3, being used was as specified on the WPS. This makes the wire flux combination an AWS classification of F7A3-EM12K. This work is for the OBG.

The QA Inspector also observed the semi-automatic Flux Cored Arc Welding of the flange portion of beam splices on the OBG. This welding was done in the vertical groove (3G) welding position using WPS-B-T-2233-B-U2-F. One of the beam splices observed was Weld No. BP003-01-007, which spliced Piece Marks RS15A to RS15C. The fabrication Drawing No. is BP3 and the weld detail is shown on Drawing No. BP003. The QA Inspector observed the ZPMC CWI, Xu Xianping (AWS CWI No. 07072071) was present during this welding.

All observations appeared to meet the requirements of the job specifications.
